# SAFETY RECALL NOTICE

Re: Can-Am™ DS 450™ Speedometer Inaccuracy (**CE MODELS ONLY**)

Campaign no.: 2009-0009

Subject: **Can-Am™ DS 450™ Speedometer Inaccuracy**  
**(CE MODELS ONLY)**

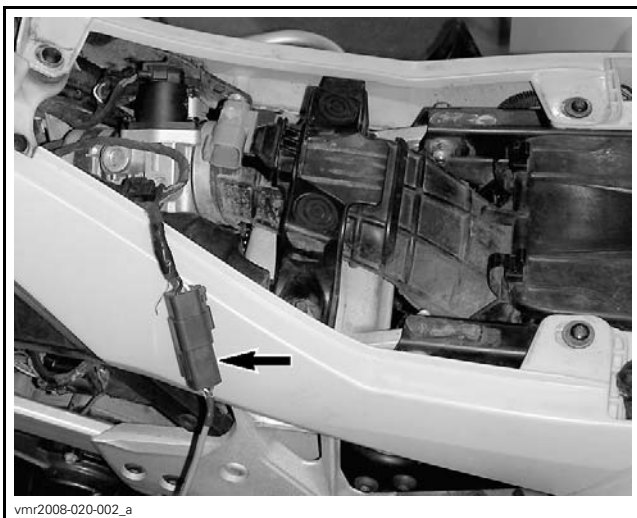
vmr2008-020-002\_a

DS 450 EFI COMMUNICATION CONNECTOR (TYPICAL)

1. Connect vehicle to B.U.D.S. Refer to *2008 CAN-AM DS 450 EFI SHOP MANUAL* — Sub-section 02 under *COMMUNICATION TOOLS AND B.U.D.S. SOFTWARE*.

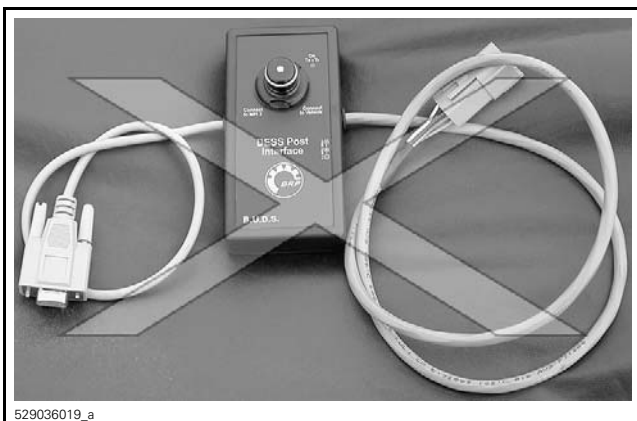
529036019\_a

DO NOT USE DESS POST INTERFACE

NOTE: Do not use DESS Post Interface (P/N 529 036 019).

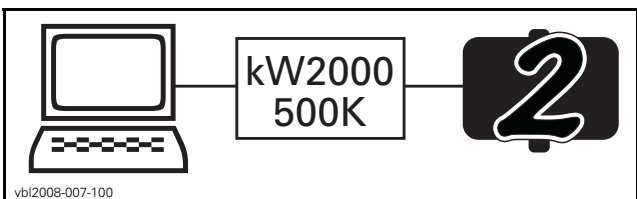
vbl2008-007-100

CONNECTION SUCCESSFUL — ECM AND MULTIFUNCTION GAUGE ARE CONNECTED

1. Turn ignition key to ON.
2. Start B.U.D.S. and logon.
3. Ensure both USB and CAN lights of MPI-2 are green.
4. Ensure the status bar shows KW2000 (500K) with the number 2 to its right.

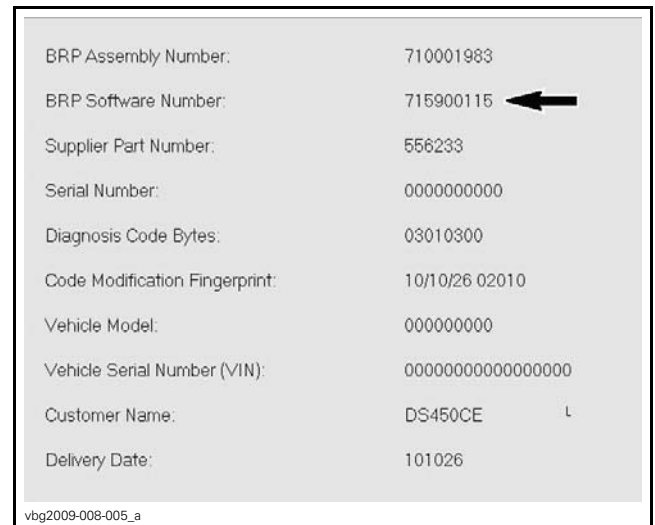
BRP SOFTWARE NUMBER
715 900 115

9. Confirm that BRP Software Number is updated by selecting:
  - Module
  - Cluster
  - Information.

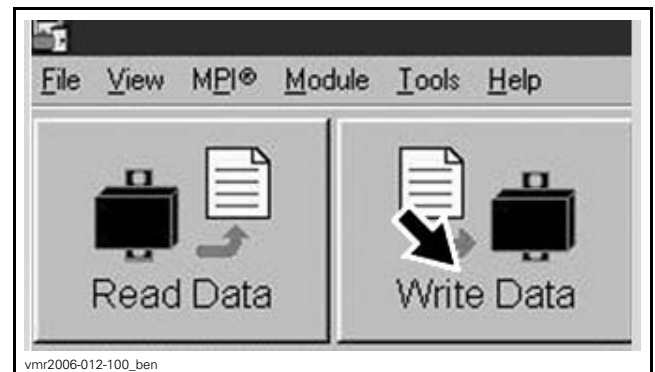
**WRITE DATA BUTTON**

10. Click on **Close** button.
11. Select **Vehicle** page in B.U.D.S.
  - 11.1 Click on **Reset Service Info**.
12. Click on **WRITE DATA** button.
