SAFETY RECALL NOTICE

Re: Ignition Switch Connector and Ignition Switch Harness Routing

Campaign no.: 2010-0002

December 18, 2009 Subject: **Ignition Switch Connector and Ignition Switch Harness Routing**

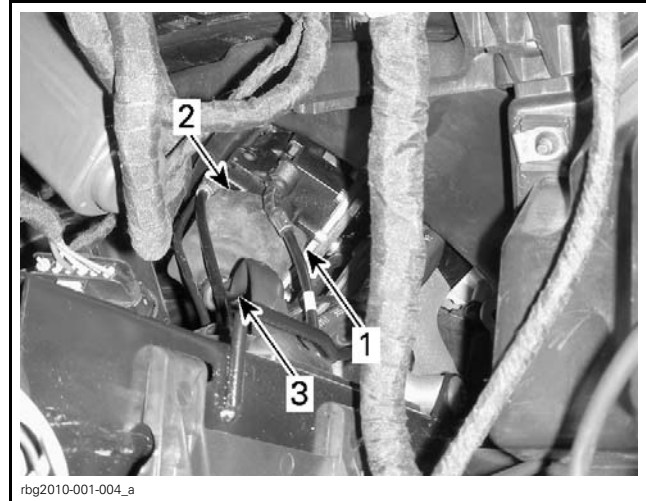
1. Ignition switch connector
2. Rubber boot
3. Ignition switch harness

2.2 Using both hands, ensure connector is well engaged in its housing and locked by locking tabs.

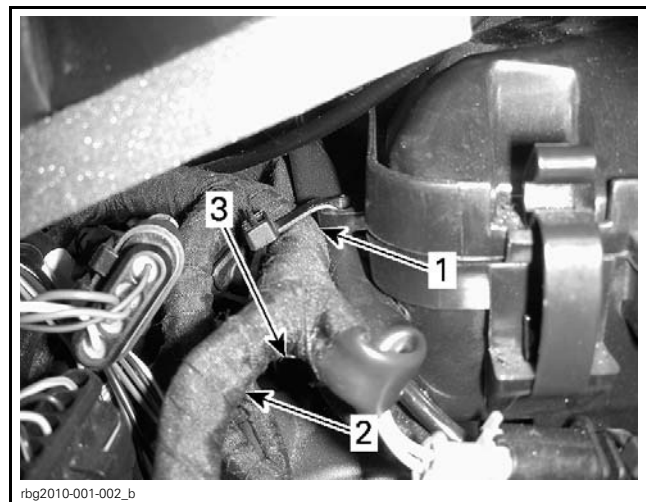
3.1 Locking tie should attach harness to air box before the branching point.

1. Wrong locking tie location on harness
2. Correct locking tie location on harness
3. Branching point

3.2 If locking tie position is incorrect, proceed with the repair procedure.

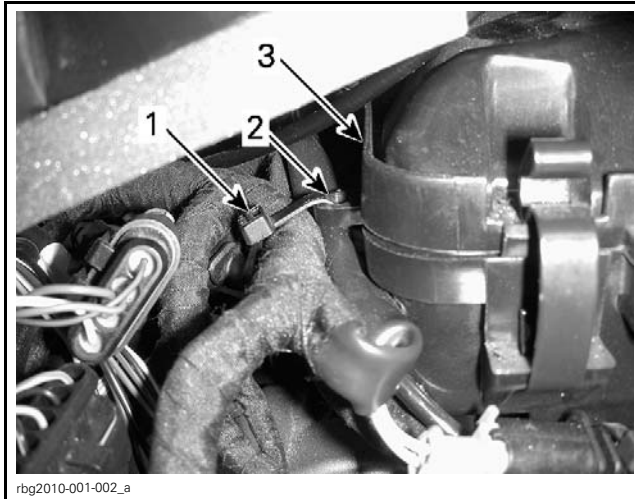
1. Tie rap
2. Attachment point on air box
3. Air box

1. Cut locking tie located on vehicle harness in front of air box.

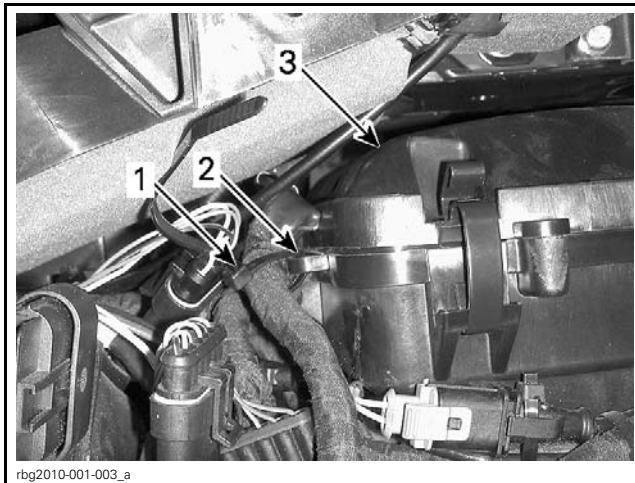
1. Locking tie
2. Attachment point on air box
3. Air box

2. Pull ignition switch harness towards front of vehicle from LH headlight opening.
3. Push harness from LH of vehicle to align with the attachment hole on air box.
4. Verify harness is not tight by pulling from LH headlight opening.
5. Reinstall new locking tie to attach ignition switch harness to air box.

6. Turn steering completely to the LH side and RH side to ensure ignition switch harness is not tight in any position.
