ROADSTER
WARRANTY
Bulletin

Campaign no.: 2012-0002

Subject: **Spyder™ RT – RH Lateral Support Replacement**

No. **2012-2**

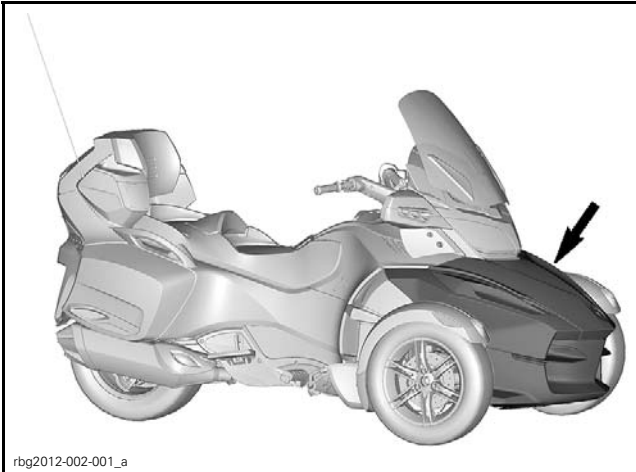
rbg2012-002-001_a

1. Refer to the appropriate Shop Manual and remove the front cargo module.

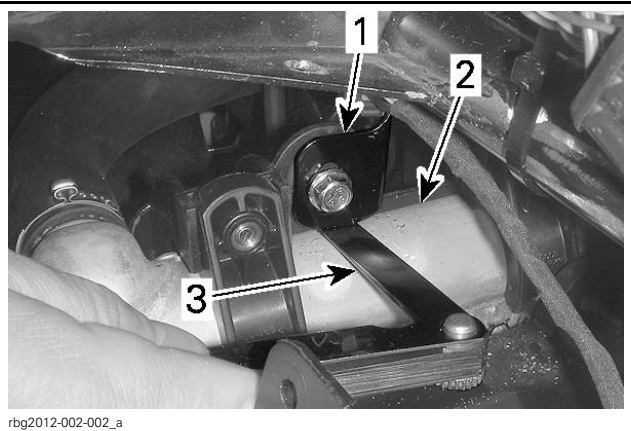
rbg2012-002-002_a

On some units, the RH lateral support may be too close or come in contact with the top of the radiator.

2. Measure clearance.

1. Lateral support bracket
2. Radiator
3. Feeler gauge (stack of 2 mm (.079 in))

MEASUREMENT RESULT	ACTION
2 mm (.079 in) or more	No action required. Reinstall removed parts.
Less than 2 mm (.079 in)	Replace RH lateral support by (the (P/N 548 873 130)) Refer to the appropriate shop Manual)
