**QUALITY****ROADSTER
WARRANTY
Bulletin**

Campaign no.: 2012-0008

May 15th, 2012Subject: **Spyder™ RT – Seat Foam May be Too Firm**

2012-5

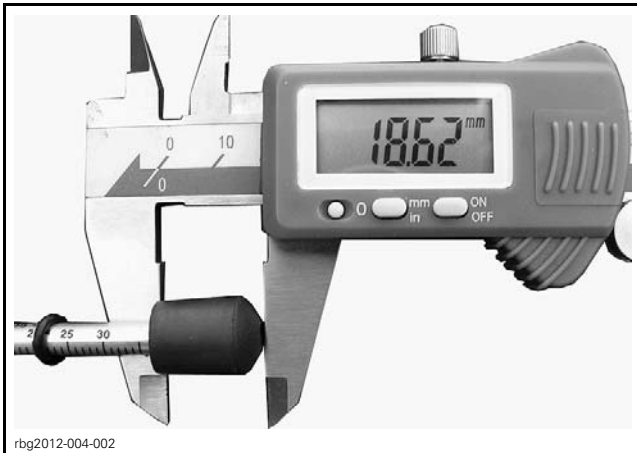
1. Measure the tensiometer rubber cap.

18.6 MM ± 0.5 MM (.732 IN ± .02 IN)

Do not use tool if rubber cap dimension is not within specifications. Order a new tool if necessary.

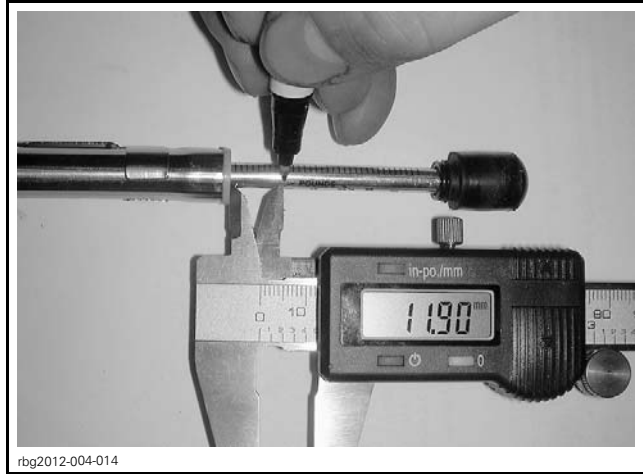
2. Mark the tool plunger:

- 2.1 Using a vernier caliper, measure 11.90 mm (.469 in) from the body edge.
- 2.2 Mark the plunger using a fine permanent marker.

NOTE: Using a marker too wide will significantly decrease precision.

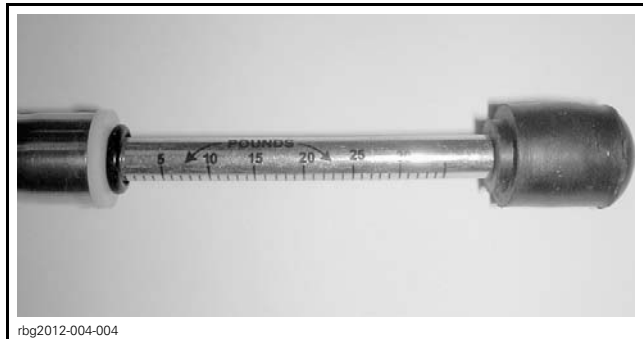
O-RING AT ZERO

3. Position the small O-ring at zero.

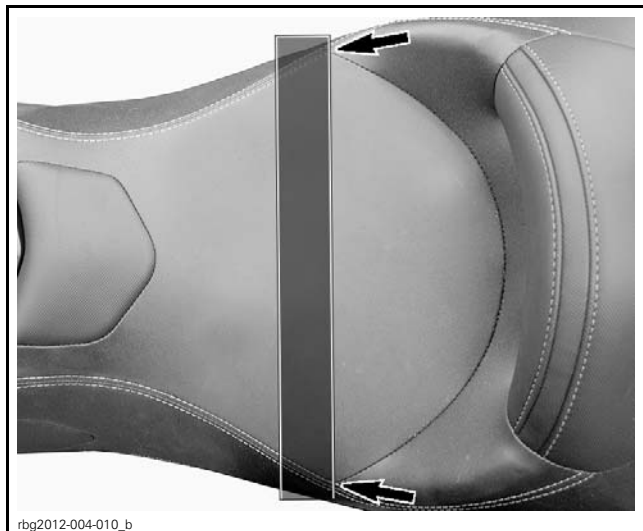
4. Position ruler on the seat as shown.

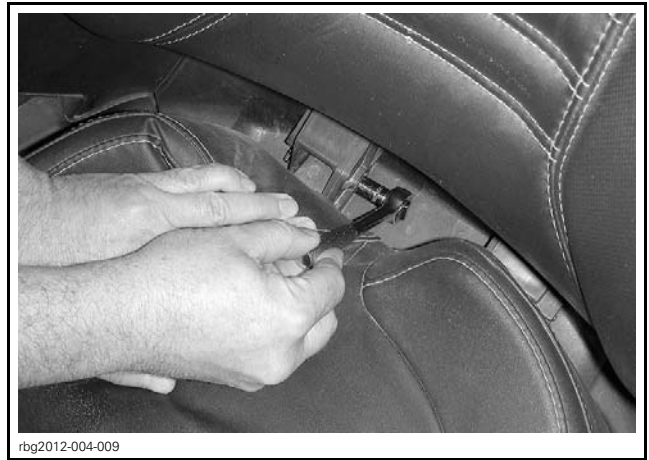
5. Latch the seat.
6. Tighten the pivot screws.

TIGHTENING TORQUE	
Pivot screws	9 N•m (80 lbf•in)

7. Check if the front of the seat has some play (up and down).
8. Check if seat unlatches smoothly.

CONDITION	ACTION
No play at front/Unlatches smoothly	Good adjustment, no action required
Play at front	Adjusted too loose. Shorten striker
Hard to unlatch	Adjusted too tight. Lengthen striker
