WARRANTY CAMPAIGN

Campaign no.: 2011-0002

Subject: **Inverted Coolant Hose on 800R Engine**

No. **2011-2**

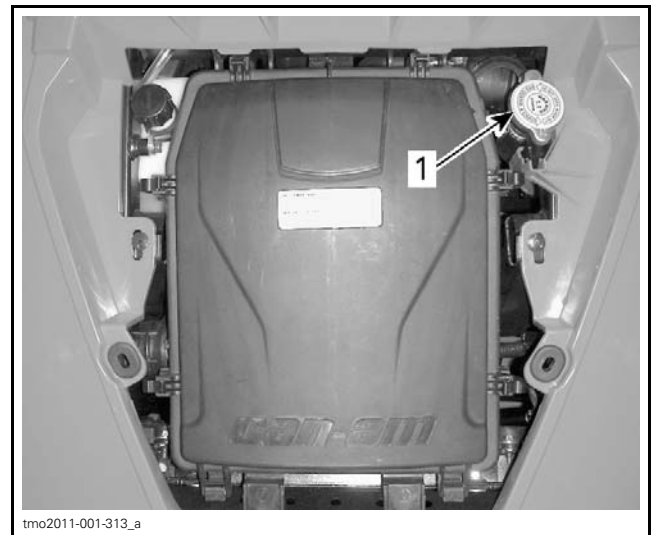
1. Pressure cap

Remove pressure cap.

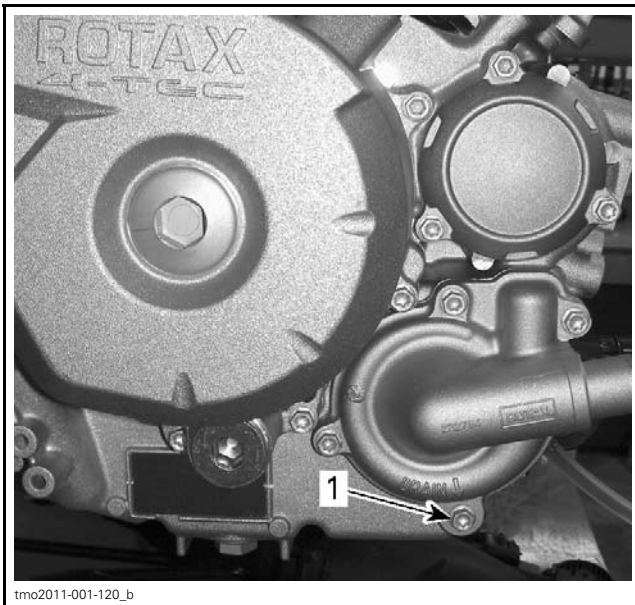
1. Coolant drain plug

Unscrew drain plug to remove approximately 1 L (1.1 qt (U.S. liq.)) of engine coolant.

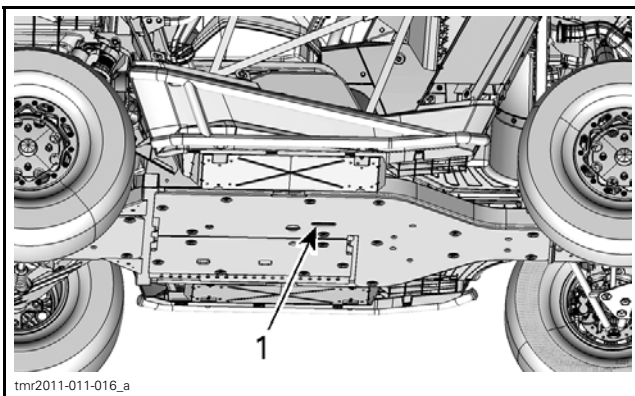
1. Cooling system drain plug access

Recover coolant in a clean suitable container.
Reinstall coolant drain plug.

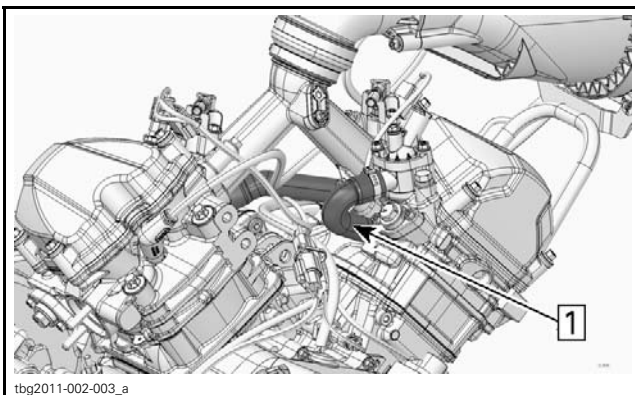
The vehicles listed in this bulletin, were delivered with a coolant hose installed in reversed position. This situation allows interference between the hose and the intake manifold which could lead to coolant hose damage.

1. Hose between cylinder heads (installed the wrong way).

Remove and discard both clamps from hose between cylinder heads.

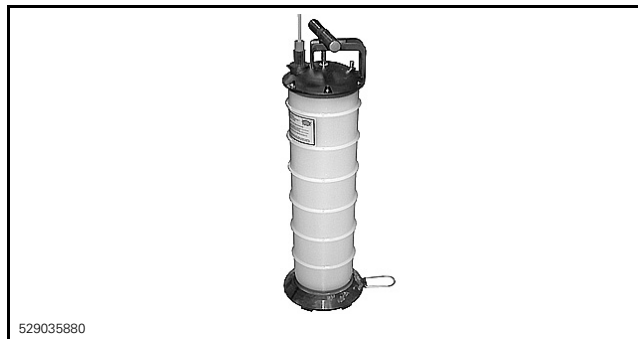
Syphon the remaining coolant in the hose using the SUCTION PUMP (P/N 529 035 880)

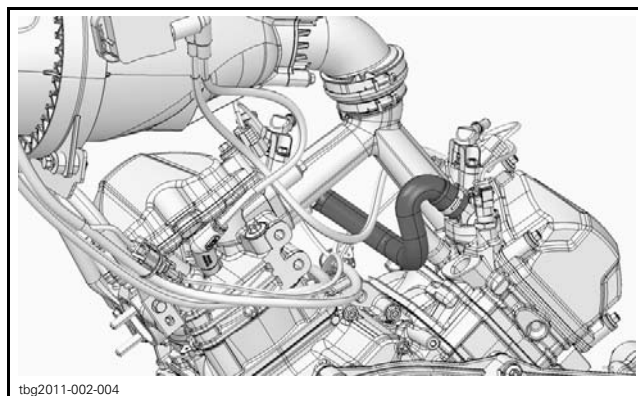
NOTE: The curved preformed section goes on rear cylinder head (cylinder #2) as shown.

1. View from PTO side (correct installation).

Reinstall coolant hose in the reverse position of removal.

Ensure there is no contact between the hose and any engine component.
