Subject: **A) New Calibration File for MY11
Commander**

No. **2011-12**

B) Maintenance Hours Reset Procedure

YEAR	MODEL	MODEL NUMBER	SERIAL NUMBER
2011	Commander 800 and 1000	All	All

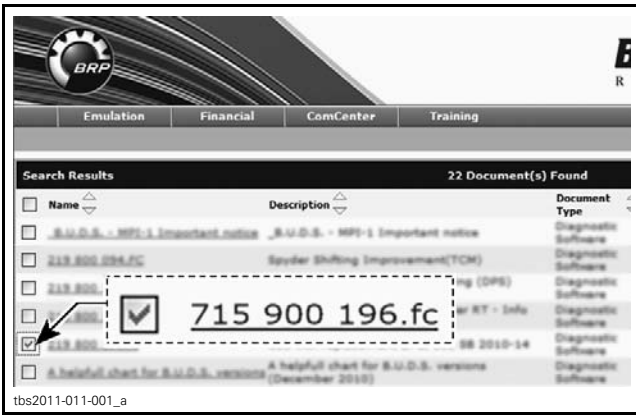
5. Select box and download the calibration update file:

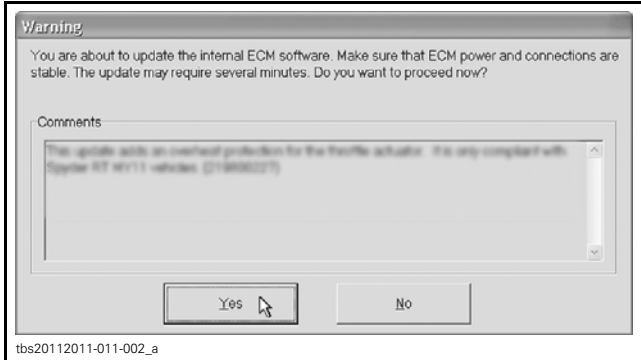
3. When the following message appears, click the "Yes" button so that the update takes place.
