WARRANTY CAMPAIGN

SIDE-BY-SIDE VEHICLES

Campaign no.: 2013-7

Subject: **Battery Gauge Accuracy**

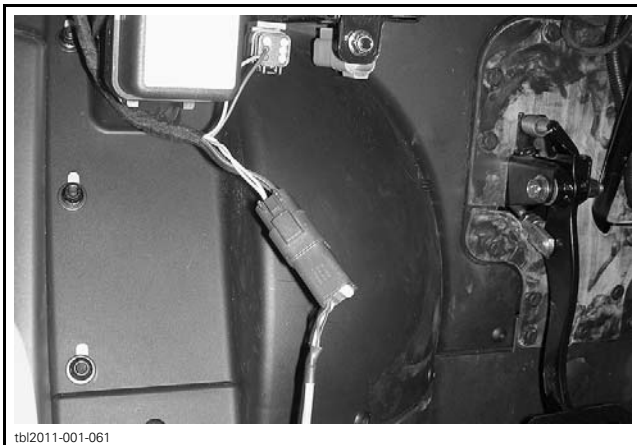
tbl2011-001-061

1. Locate the 6-pin diagnostic connector underneath dashboard on driver's side.
2. Disconnect the 6-pin diagnostic connector from it's holder (protective cap).
3. Connect one end of the MPI-2 diagnostic cable to the vehicle connector.

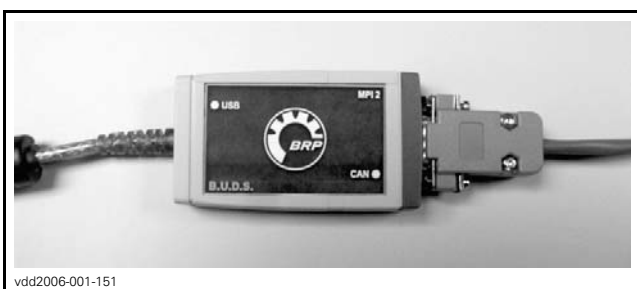
vdd2006-001-151

4. Connect the other end of diagnostic cable to the MPI-2 interface card.

DIAGNOSTIC CABLE CONNECTED TO MPI-2 INTERFACE CARD

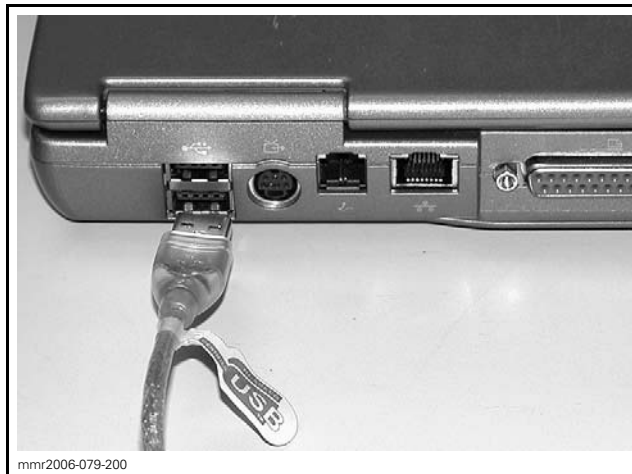
mnr2006-079-200

5. Connect the MPI-2 interface card to the USB port of a PC (personal computer).

MPI-2 INTERFACE CARD CONNECTED TO USB PORT
