ROADSTER WARRANTY Bulletin

Campaign no.: 2012-0001

Subject: **Spyder™ RS – Lateral Support Bracket Modification**

No. **2012-1**

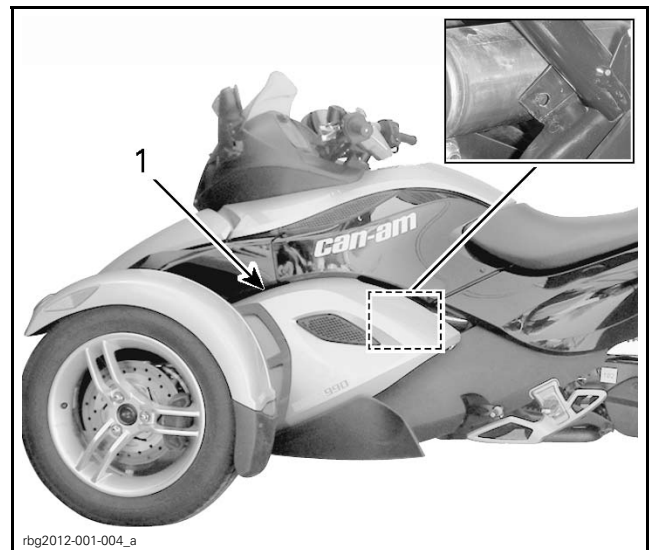
1. Remove the LH middle side panel.

1. Middle side panel (remove)

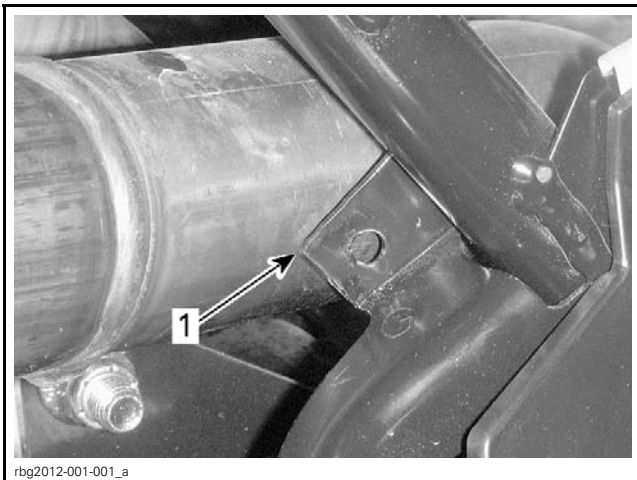
2. Verify the clearance between the bracket and exhaust pipe.

1. Minimum 7mm (1/4 in)

BRACKET INSPECTION	
At least 7 mm (1/4 in) clearance	No action required
Less than 7 mm (1/4 in) clearance	Modify bracket as follows

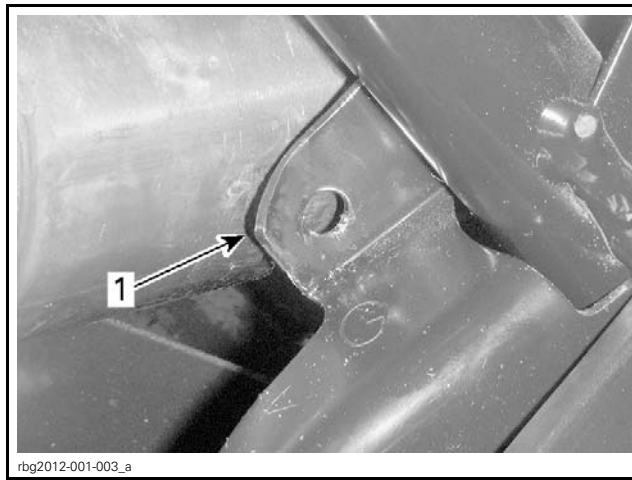
1. Bent bracket - minimum 7mm (1/4 in)

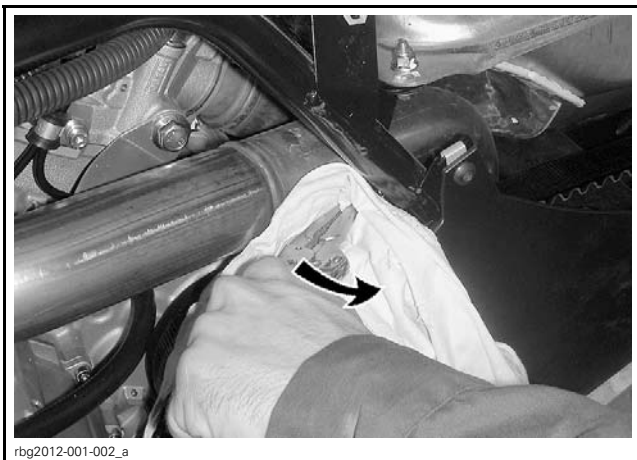
3. Bend bracket

3.1 Protect bracket and pipe finish with a rag.

3.2 Bend using suitable pliers
